Norris Corrosive Service (CS) Sucker Rods reduce failures in a low-viability well with high water cut and deviated wellbore

CASE HISTORY

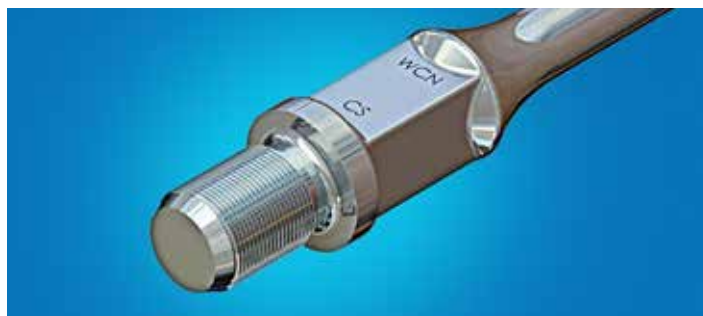
Image: Norris WCN™ Corrosive Service (CS) sucker rod

- ▶ A custom-designed rod and guide string was installed
 - Features Norris Corrosion Service Sucker Rods
 - Corrosion Service Sucker Rods have high ductility and high tensile strength
 - Constructed of special alloy steel and designed heat treatment that resists corrosion while maintaining tensile strength
